## Otter (*Lutra lutra*) mortality and road bridge design in Loch Lomond and The Trossachs National Park

### ABSTRACT

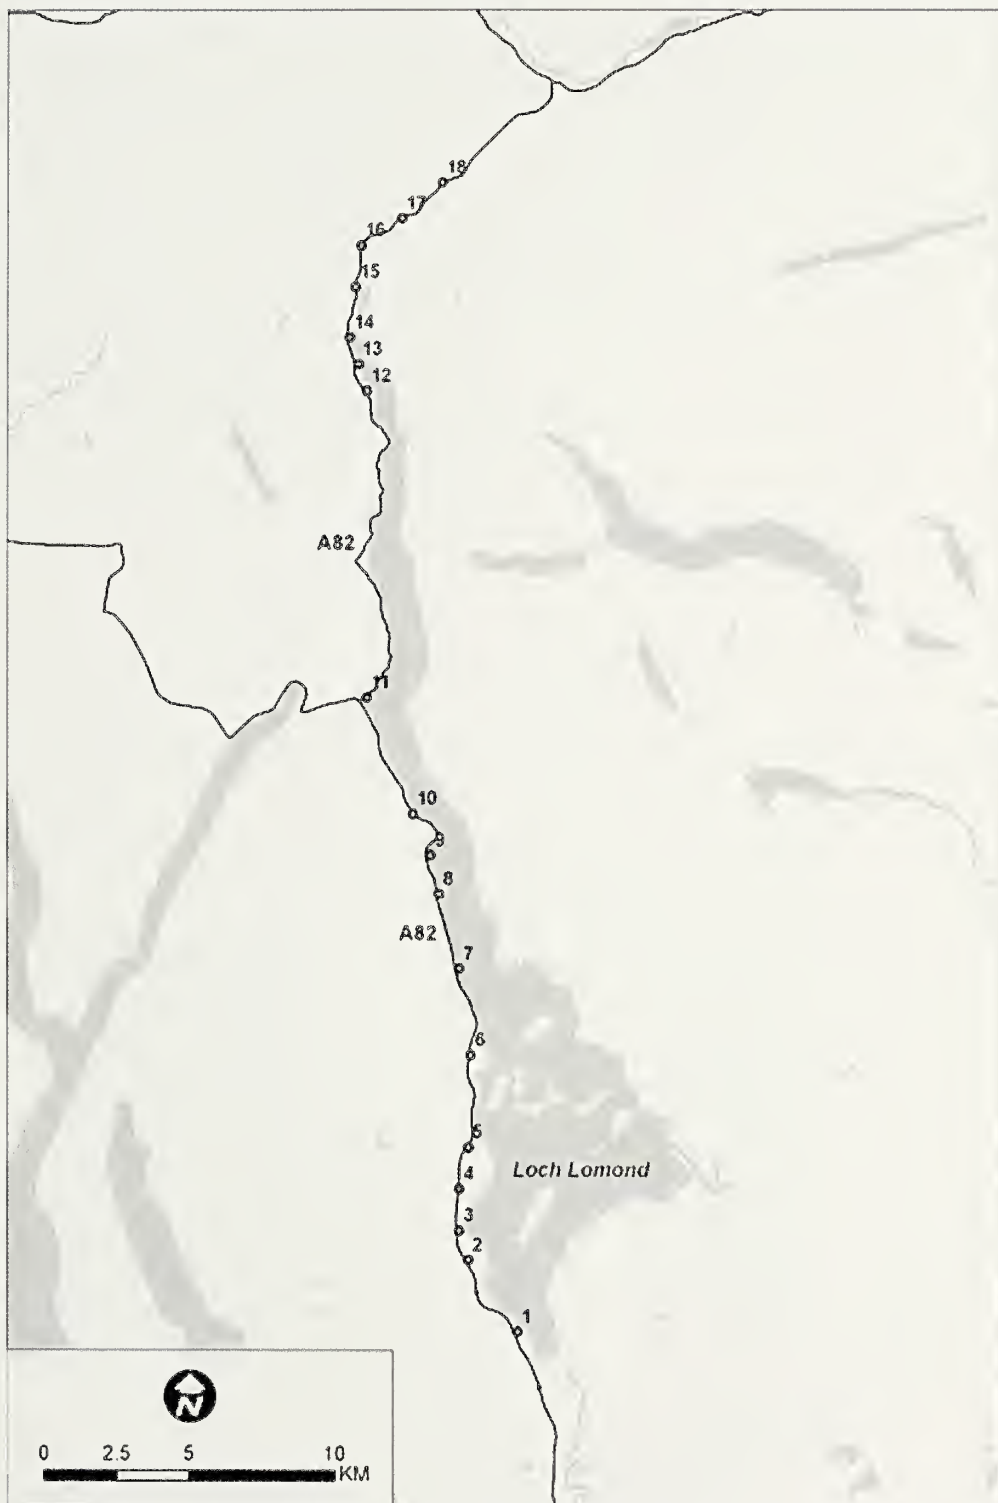
Fig. 1. Locations of bridge sampling sites surveyed on the A82 at Loch Lomond.

Eighteen sampling sites were chosen where watercourses passed under the A82. Not all the watercourses along the A82 were covered in the survey due to restriction in the survey time available. The sites were spread along the length of the A82 from the south end of Loch Lomond to Crianlarich (Fig. 1). The sites were selected to cover a variety of different sized water courses which were practical to sample. The maximum width of the watercourses ranged from just less than a metre to just over 30 metres. Each site was visited fortnightly for 10 weeks from the 2<sup>nd</sup> of May until the 11<sup>th</sup> of July 2007. On the first visit any otter signs (spraints or footprints) were removed but not recorded as the timescale for their deposition was unclear. For the remaining five visits all information was recorded.

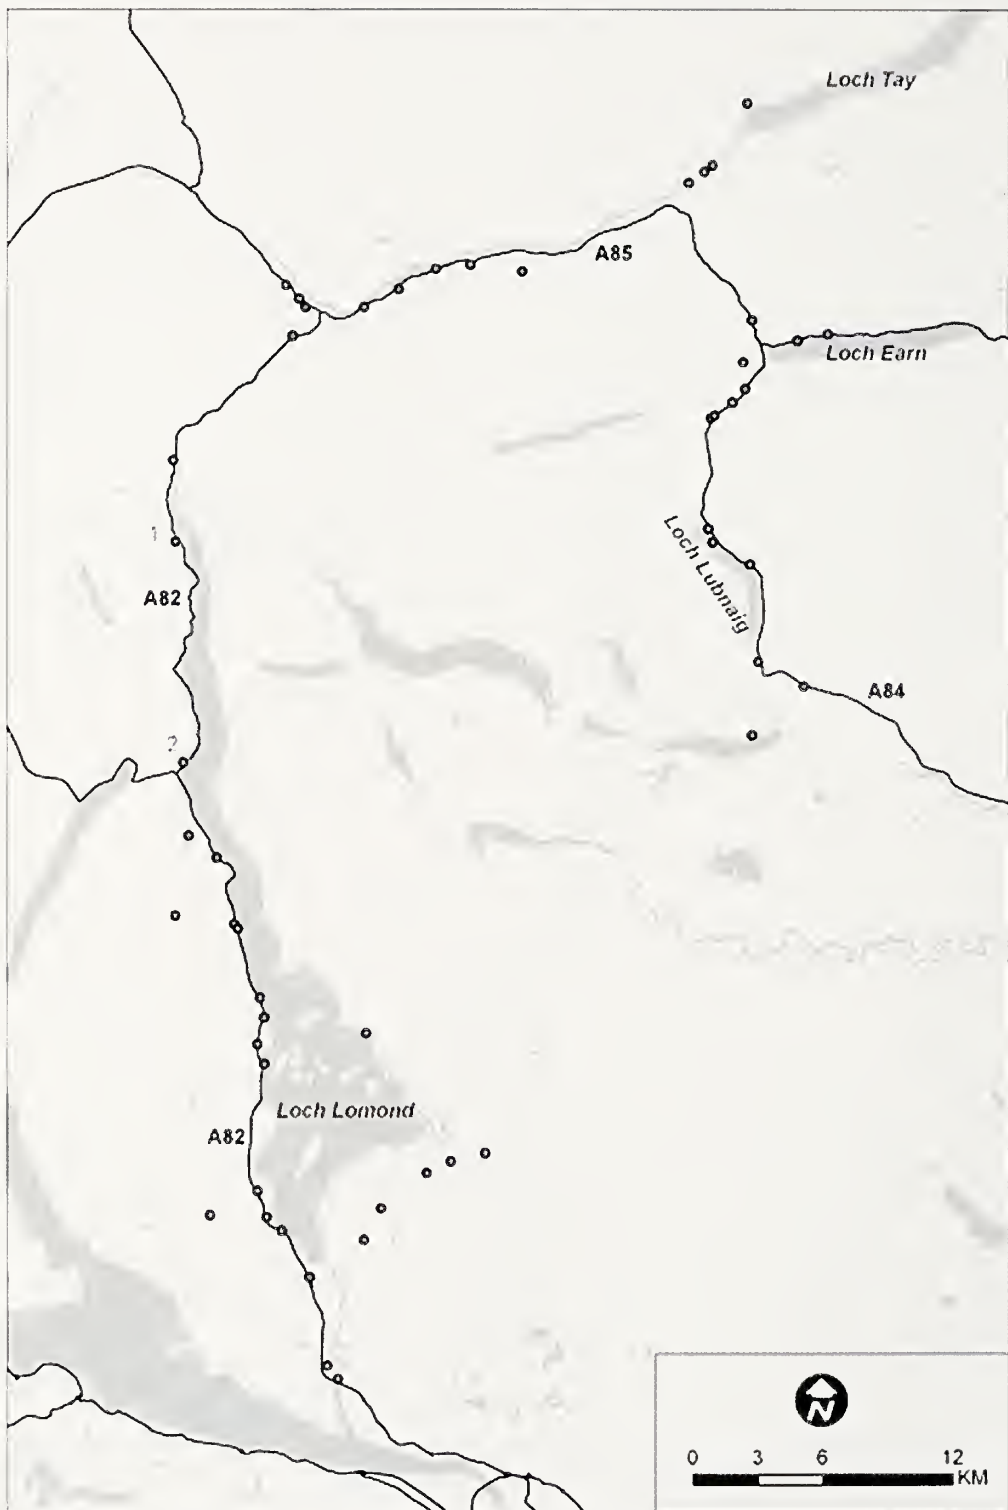
**Fig. 2.** Locations of otter road mortalities in the Loch Lomond and The Trossachs National Park. Points numbered 1 and 2 are estimated from incomplete grid references and general descriptions.

females, of which 33 adults were recorded and 18 juveniles. This information was used to plot a map of deaths in LL&TNP area (Fig. 2). The data set contained information on year, month, age, sex and location of the mortalities. However not all mortalities recorded had a complete set of information. The sample size and categories for each characteristic is shown in Table 2. The distance to the nearest water body for each mortality was measured using 1:50,000 Ordnance Survey maps.
